Impact Crushing Injury (Port of Miami) Expert Investigation Article

Impact Crushing Injury

EXPERT INVESTIGATION

Port Safety Services (PSS)

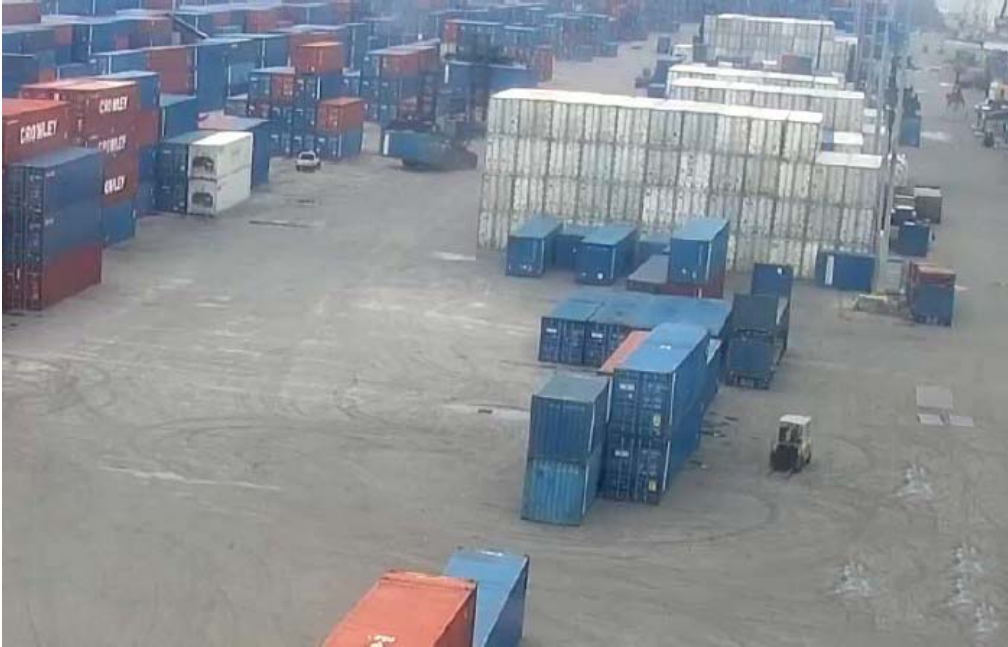
Figure 2. Stacks of 20' intermodal shipping containers (White units are refrigerated or Refers)

Shipping containers or “Cans” are large metal boxes (*See Figure 2.*) used for loading and conveying palletized goods across different modes of transport, including ships, trains, and trucks, without the cargo needing to be unloaded or reloaded. International container shipping sizes include 20', 40', and 45' cans holding 10 to 22 loaded pallets, with a maximum loaded weight of 44,000 lbs. There are also 53' containers used in commerce. In this crushing injury case at the Port of Miami, the subject container was a 20' loaded unit, with an undetermined weight. A Loaded Container Handler a.k.a. Top Handler (*Figures 3-4.*) was the type of PIT involved in this injury case. To compare a Top Handler with a small sized pickup (*See Figures 3-6.*)

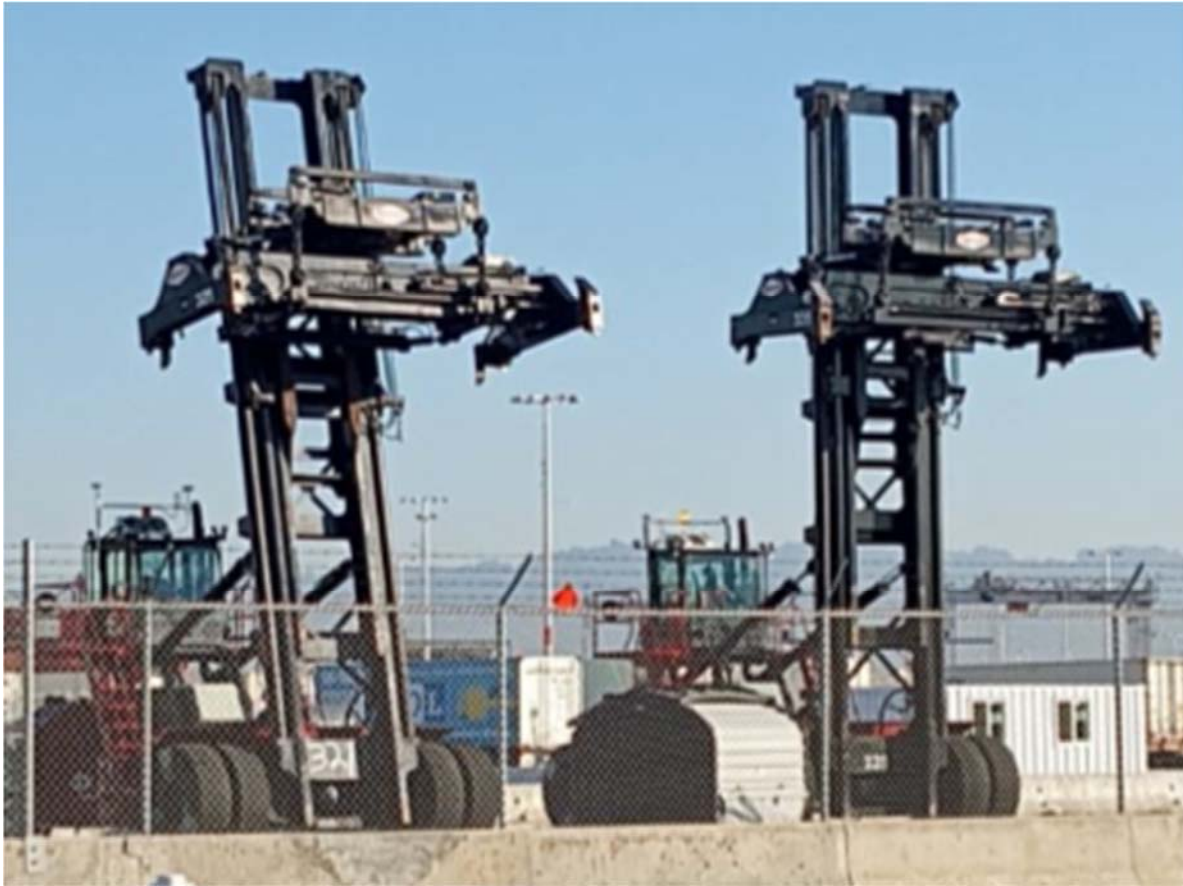
Figure 4. Loaded Container Handlers (Top Handlers or PITs)

Specifications of Loaded Container Handlers (Top Handlers):

- Gross Unit Weight 52,000 lbs. / 26 Tons approx.
- 97" Load Center
- 42-ft Telescopic Mast for stacking cans 5-High
- Maximum Cargo Weight: 90,000 lbs.
- Spreader (On Mast) 20'-40' ISO Container Handling Attachment
- Rated Capacity At 97-in. (2,464 mm) Center of Load
- 90,000-lbs. (40,824 kg) / 2-high Stacking
- 80,000-lbs. (36,288 kg) / 5-high Stacking
- Rated Capacity At 106-in. (2,692 mm) Center of Load
- 82,000-lbs. (37,195 kg) / 2-high Stacking
- 75,000-lbs. (34,020 kg) / 5-high Stacking
- 236-in. (5,994 mm) Wheelbase

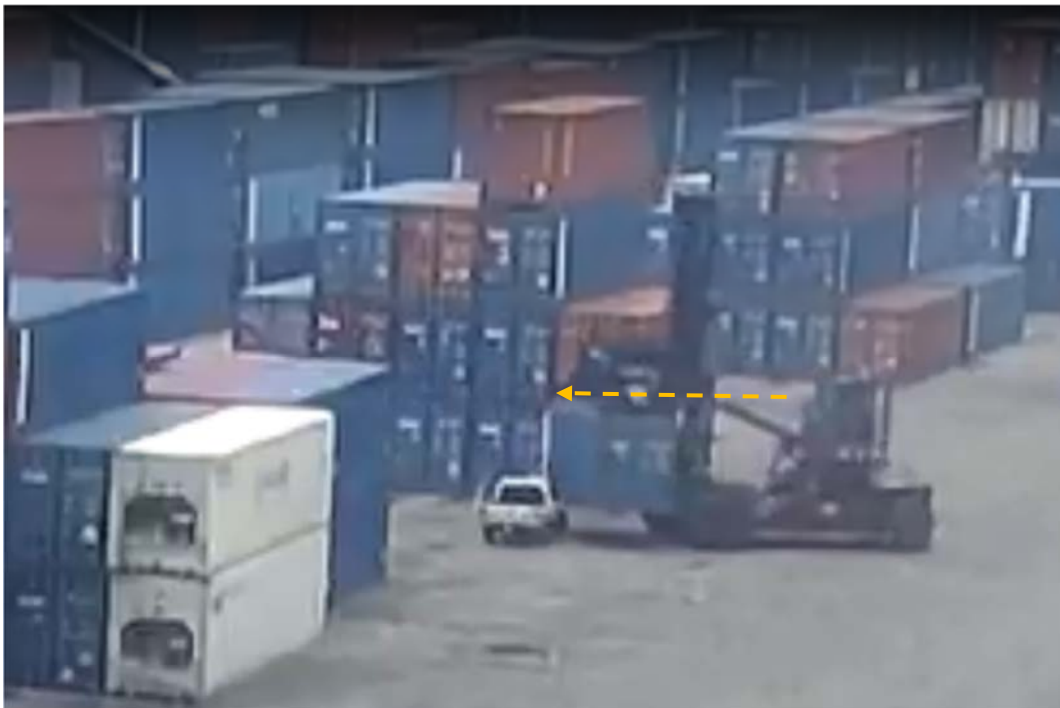
Due to the Top Handler Operator's lack of situational awareness and focus on the day of injury, the operator chose to carry the loaded container low, which effectively blocked his view of the roadway during travel. This unsafe act caused him to be unable to see a parked vehicle directly in his forward direction. This oversight resulted in an impact crushing injury to the superintendent. Upon impact, the supervisor's vehicle was shoved steadily forward by the advancing Top Handler (container), as it crushed the cab and compressed the pickup into the stack of heavily loaded containers. (See Figure 7.) The action of blocking the view of the travel path was a violation of the OSHA powered industrial truck (PIT) operating rules. (See CFR §1910.178(n)(4) below)

Figure 5. The moment of impact (as seen from a video screen grab), as the carried load (obstructs the forward view) strikes the stationary white pickup, crushing the cab and seriously injuring the occupant

*CFR §1910.178(n)(4), OSHA Rules for Powered Industrial Trucks:
If the load being carried obstructs forward view, the driver shall be required to travel with the load trailing.*

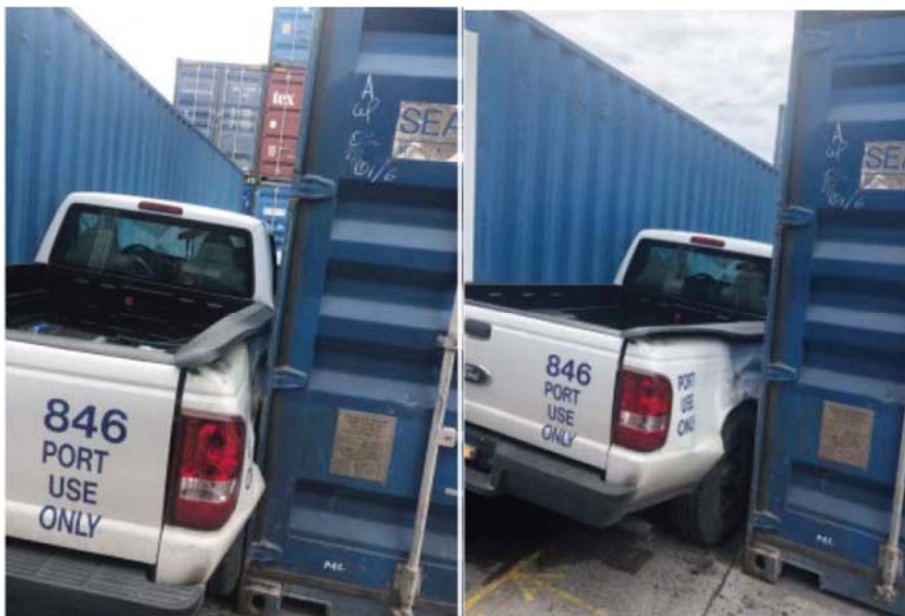
Figure 7.

Post impact, the superintendent for the stevedore company sustained significant crushing injury to his left leg, requiring major surgery and months long ambulatory. (See Figure 7).

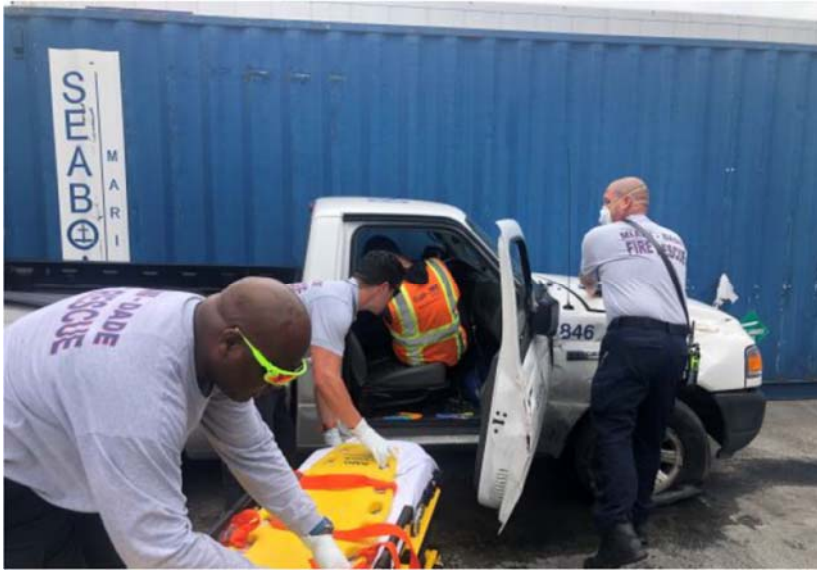
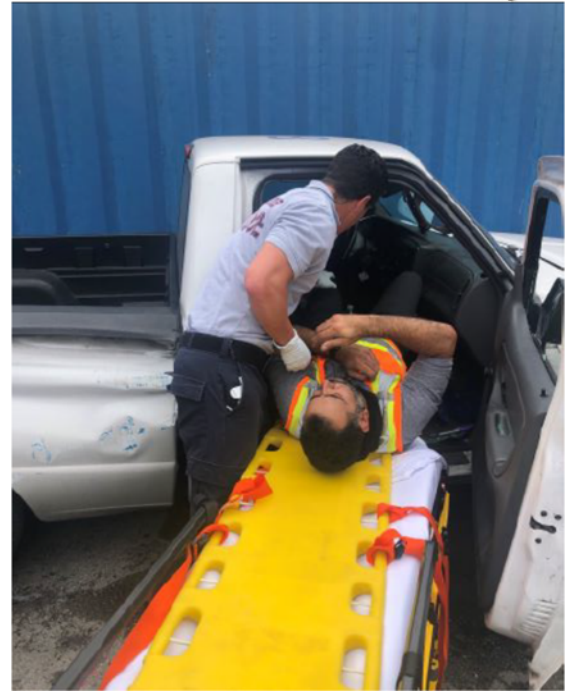
Figure 8.

Post incident after the top loader moved some of the containers free, the Miami-Dade Fire & Rescue were able to extricate the victim and transport to emergency care. (See Figure 8).

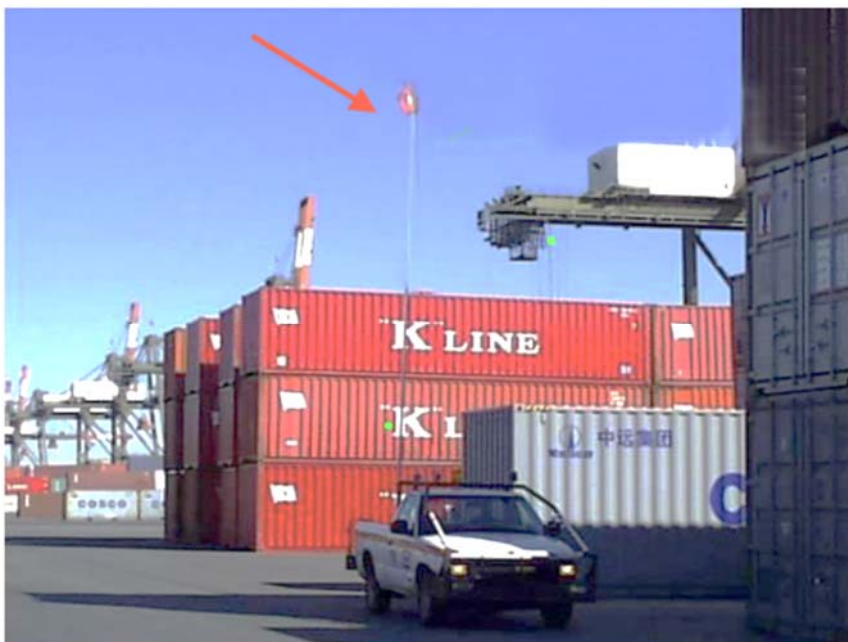
Figure 9. Elevated & Illuminated Poles for small vehicles, photo courtesy of ILA~USMX Joint Safety Committee

The employer of the superintendent (a port stevedore company) failed to ensure that service vehicles were outfitted with flexible, high-elevation illuminated poles, that make clear the presence/location of each such vehicle. (*See Figure 9.*)
